Sizewell C Notice to Mariners No 15 of 2026

Marine Construction Zone Update

Marine Construction Zone Special Mark – Light unreliable

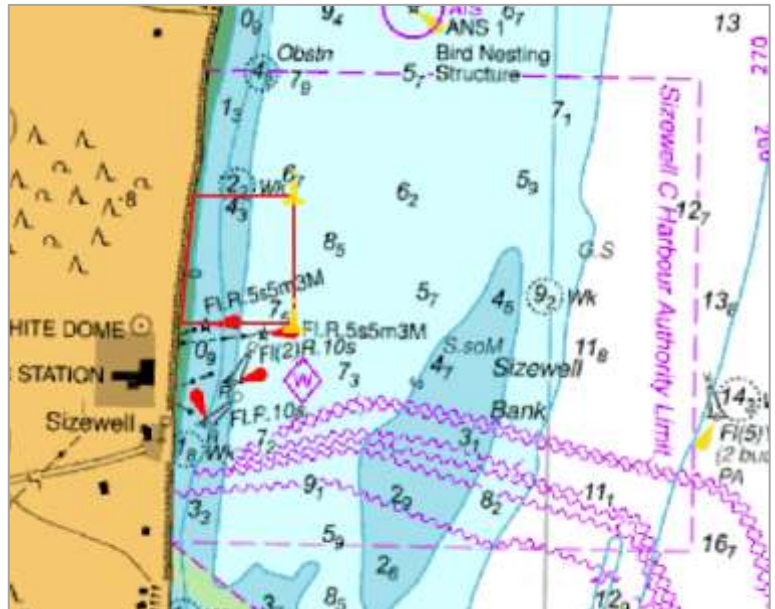
The Fl y 5s light on the special mark buoy marking the SE extremity of the Marine Construction Zone (MCZ) has been reported as unreliable – the position of the buoy in question is as below and is indicated on the accompanying chartlet. Mariners should proceed with caution when navigating in this area.
